# NATIONAL REGISTER OF HISTORIC PLACES REGISTRATION FORM

1. Name of Property			
historic name: Fort Missoula Historic District (Bound	dary Increase)		
other name/site number: 24MO0266			
2. Location			
street & number: Reserve St. and South Ave.		not for publication	on:
city/town: Missoula		vicinity:	
state: Montana code: 030	county: Missoula	code: 062	zip code: 59807

Name of Property: Fort Missoula Historic District Roundary Increase 1

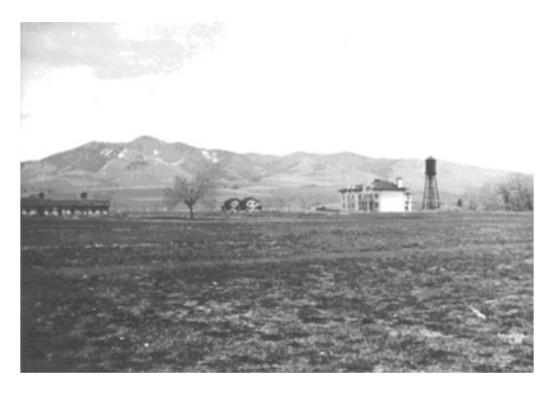
Figure 6. Fort Missoula Post Hospital and Water Tower, 1912 (Courtesy of the Historical Museum, Fort Missoula).

The original viewshed of the Fort was extensive on three sides. The natural vegetation along the Bitterroot River hampered the view from and towards the Fort on the south. The distance from the main town, and its increasing residential and commercial construction, coupled with the open design, flat topography, and sparse vegetation, provided an expansive view from and towards the Fort. (See Figures 76 and 80). After the reconstruction of the Fort in the early 1900s, the new officers' quarters and barracks reduced the direct line of sight to the east. Even so, the Fort viewshed was still fairly expansive and its configuration in an open prairie on the north bank of a bend in the Bitterroot River was still quite evident. (See Figures 8, 9, 10, 11, 16, and 17). During this phase of the Fort's development, the water tower was one of the more prominent elements. (See Figure 6).

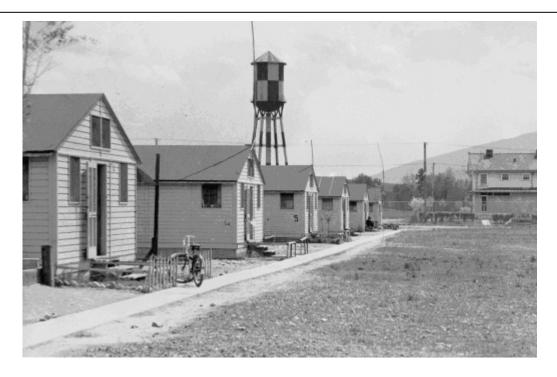
Figure 14. Fort Missoula Internment Camp Barracks, 1945 (83.39, Archives and Special Collections, The University of Montana - Missoula).

The internee barracks constructed in the 1940s were built on concrete pads and were simple wood frame structures with lap siding and gable roofs. (See Figure 14). During this timeframe, guard towers and tall metal fencing were used around the perimeter of the internee camp. These elements were later removed. The wood frame Provost Marshall's office was added circa 1945 (Wallace Long, personal communication, February 20, 2008). Two concrete-block, flat-roofed, cell blocks, located on the eastern edge of the Fort were added circa 1946 (McDonald and Bick 1986). At the conclusion of the use of the Fort as an internment camp and prison, the barracks erected to house the internees, the guard towers, and tall fencing were dismantled and removed and use of the Fort strictly as an army military post ended. A total of twelve additional structures were erected within the main Fort complex after 1947. Most of these are maintenance and ancillary buildings for existing structures, with the exception of the Bureau of Land Management office built in 1984 (McDonald and Bick 1986).

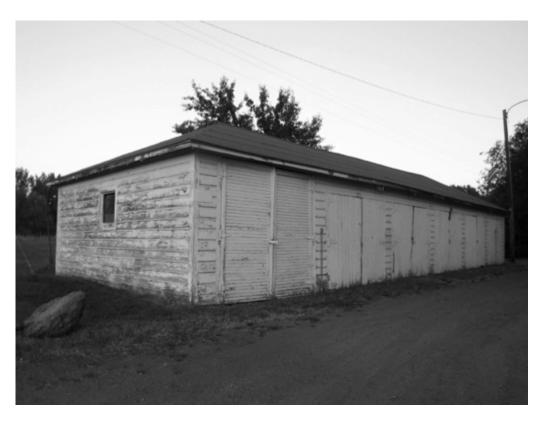
Figure 21. Building 11, Garage, Fort Missoula.

Building 11, (one contributing building), is a one-story balloon frame garage built by the Civilian Conservation Corps (CCC) (Ed Sharp Collection, Map B - 1388, Montana Historical Society, Helena). The structure has a hipped roof with green rolled asphalt roofing. It has traditional wall cladding using horizontal wood boards in a simple drop style. It has open eaves with exposed rafters, one single pane wood frame window on both the east and west ends, and six sets of double doors on the north side. The white paint on the main structure is deteriorated. Historic photographs provide evidence that Building 11 was present by at least 1940-1942, indicating it was most likely built in 1938 when several other Fort buildings were constructed. (See Figures 13, 78, and 86). The Western Montana Mental Health Center is currently using the structure for storage. (See Figure 21). Building 11 is in good condition and has retained integrity.

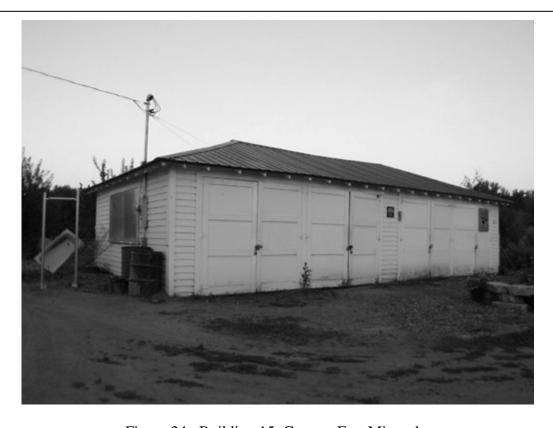
Figure 24. Building 15, Garage, Fort Missoula.

Building 15, (one contributing building), is a one-story balloon frame garage built circa 1938, possibly by the CCC. The structure has a hipped roof and open eaves with exposed rafter ends. It currently has corrugated metal roofing that has been added since its original construction. Building 15 has traditional wall cladding with horizontal wood boards in a simple drop style. There are four sets of double doors on the northeast side. On the northwest side there are two wood frame fixed 12 pane windows and one paneled door. There is also one large window on the southeast side. Historic photographs provide evidence that Building 15 was present by at least 1940-1942, indicating it was most likely constructed in 1938 when several other structures at the Fort were constructed. (See Figures 13, 78, and 86). The building is similar in design, materials and construction to other garages built by the CCC. The building is of the proper age to be associated with the CCC. The CCC constructed numerous buildings at Fort Missoula during this time period. The historic record indicates that the CCC was the only agency constructing buildings at Fort Missoula at this point in time. Even though there is no documentary evidence to directly associate this building with the CCC, the preponderance of evidence suggests this building was constructed by the CCC. It is currently owned by the University of Montana and is used for storage. (See Figure 24). Building 15 is in good condition and has retained integrity.

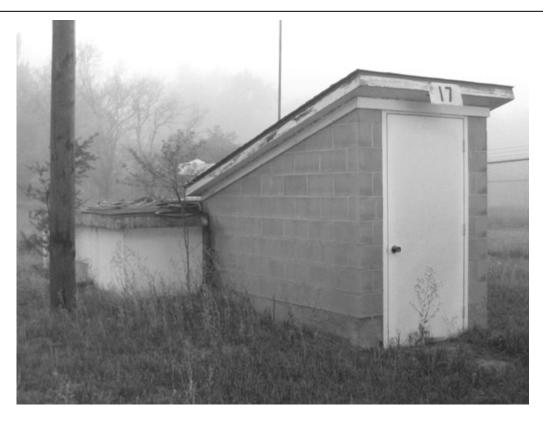
Figure 26. Building 17, Pump House, Fort Missoula.

**Building 17**, (**one contributing building**), was constructed in 1911 as a pump house in association with the Fort water tower (The Sunday Missoulian, 9 April 1911). Building 17 consists of a semi-subterranean concrete bunker with attached concrete block entrance shed. The bunker is approximately 11 feet (ft) 5 inches (in) square with a 12 ft 5 in square slightly sloped concrete lid or roof. The roof has an extended cylindrical access pipe in the center. The bunker is white-washed and has egress windows on the north and south sides. The entrance shed is 7 ft 5 in long by 5 ft wide. It has a shed roof and a door on the east. (See Figure 26). Its exterior is unchanged although the interior is vacant with the original equipment removed. Building 17 is in good condition and has retained integrity. The Northern Rockies Heritage Center (NRHC) currently owns the structure.

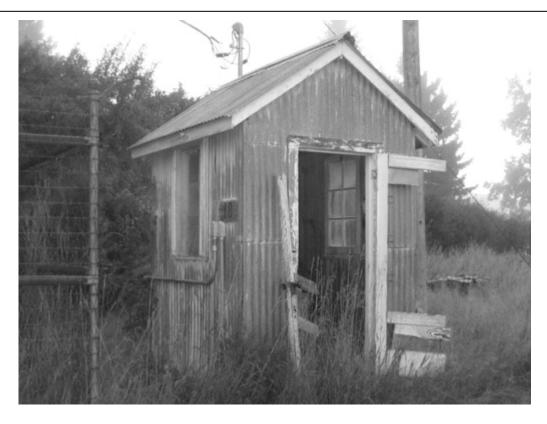
Figure 27. Building 18, Transformer Shed, Fort Missoula.

is vacant. Even though the original equipment has been removed from the interior, the exterior is unchanged. Building 18 is in fair condition and has retained integrity.

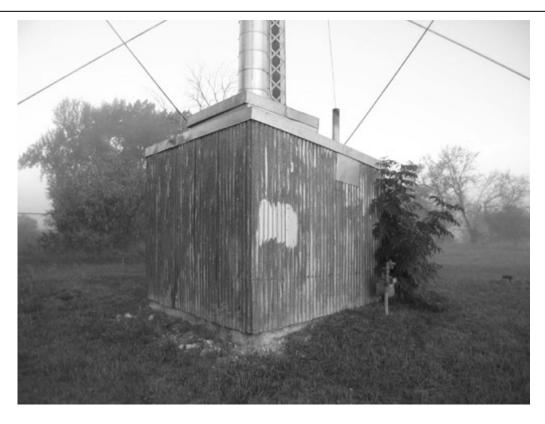
Figure 28. Building 19, Shed, Fort Missoula.

**Building 19**, (one contributing building), is a one-story balloon frame structure built in 1911 as a well-housing shed used to protect the connection between the Fort water tower's tank and the tower's well (The Sunday Missoulian, 9 April 1911). The original nomination form lists Building 19 as the Fort water tower. The correct number designation for the water tower is 51. Building 19 is located slightly west of center directly under the tower tank. This structure is 10 ft by 8 ft 6 in with corrugated sheet metal siding, a shed roof, and a door on the north side. The electrical box on the west side and the meter on the east side are not currently operating. A single central metal pipe runs from the cone-shaped base of the water tank into the roof of Building 19. The building is unchanged and is currently owned by the NRHC. (See Figure 28). Building 19 is in good condition and has retained integrity.

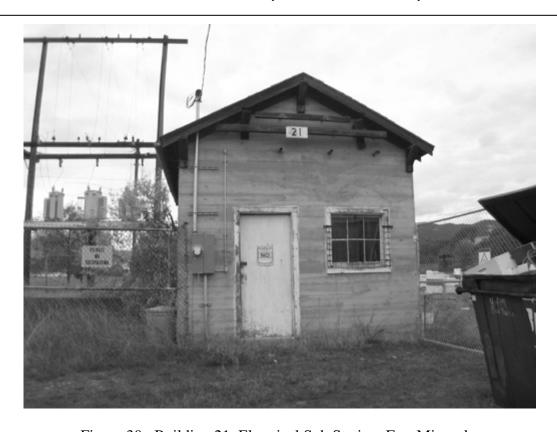
Figure 30. Building 21, Electrical Sub Station, Fort Missoula.

**Building 21**, (one contributing building), is a one-story frame structure built for the Alien Detention Camp (Internment Camp) as an electrical substation. It has a front gable roof with asphalt shingle roofing, wood plank siding, and wide boxed eaves with brackets. It has one wood frame door and one fixed six pane wood frame window on the west side. It was originally listed as being constructed in 1954 but historical photographs indicate its construction timeframe as circa 1940. Historic photographs provide evidence that Building 21 was providing electricity to the Detention Camp facility in the early 1940s. (See Figures 13 and 79). It is currently vacant with the original equipment removed. (See Figure 30). Building 21 is in good condition and has retained integrity. It is owned by the NRHC.

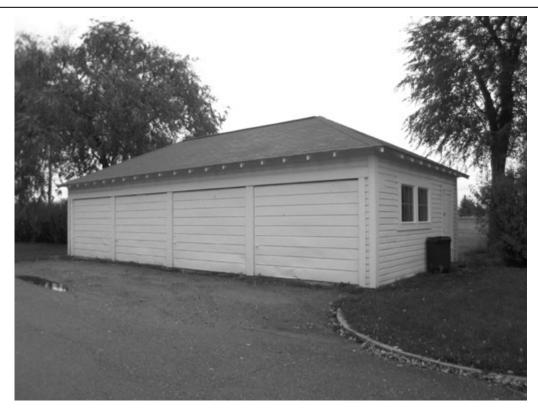
Figure 42. Building 36, Garage, Fort Missoula.

**Building 36**, (one contributing building), is a four-car garage with balloon frame construction. (See Figure 42). This structure is identical to Building 34 with the exception that the windows are 3 over 3 paned and fixed. It was built in 1938 (Jim Azzara, personal communication, January 15, 2008). It is currently owned by the NRHC. The building is similar in design, materials and construction to other garages built by the CCC. The building is of the proper age to be associated with the CCC. The CCC constructed numerous buildings at Fort Missoula during this time period. The historic record indicates that the CCC was the only agency constructing buildings at Fort Missoula at this point in time. Even though there is no documentary evidence to associate the building with the CCC, the preponderance of evidence suggests this building was constructed by the CCC. Building 36 is in good condition and has retained integrity.
